# Manhole Inspection Summary

Manhole # **S13S\_\_012MH**

Insp Date: **5/6/09 11:10 AM**

**Location** Address: **3101 WILMINGTON AV**

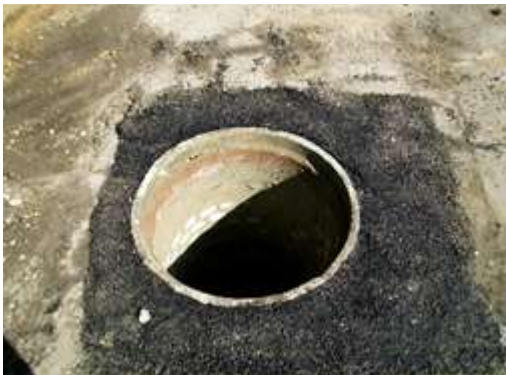
Miscellaneous

MANHOLE WAS RAISED

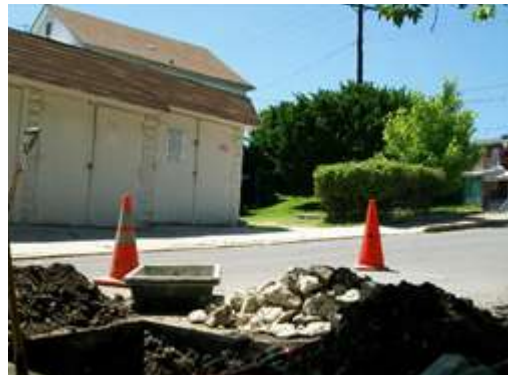
Miscellaneous

ADDITIONAL LOCATION VIEW

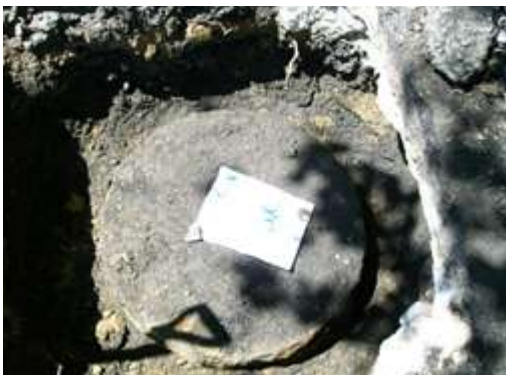
Miscellaneous

MANHOLE REQUIRED ADJUSTMENT

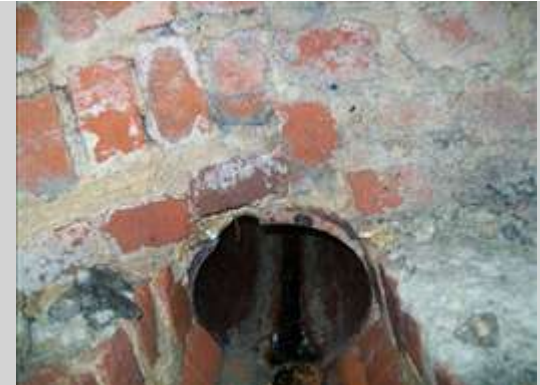
12 O'Clock Outflow

8 in. Circular Gravity Sewer  
Pipe Out @ 12 O'Clock

Pipe Height: **8.4** (in.) Rod and Bar (Angled)  
Pipe Material: **Clay** ☒ Pipe Lined  
Invert Depth: **9.00** (ft.) Flow Characteristics: **None**  
Deposits: ☒ None ☐ Mud ☐ Sludge ☐ Debris ☐ Grease  
Silt Depth: **0.5** (in.) Deposits Extent: **Light**  
Infiltration: **None** Pipe Seal Cond: **Cracked**

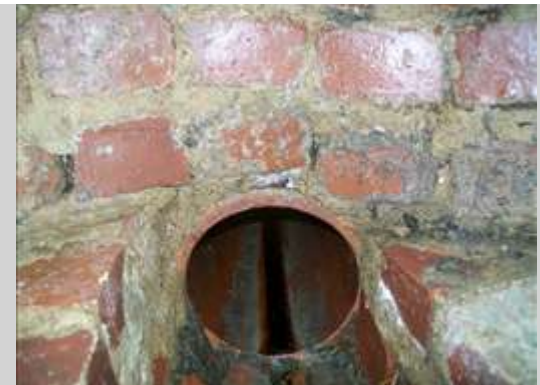
5 O'Clock Inflow

6 in. Circular Gravity Sewer  
Pipe In @ 5 O'Clock

Pipe Height: **6** (in.) Rod and Bar (Angled)  
Pipe Material: **Clay** ☐ Pipe Lined  
Invert Depth: **8.90** (ft.) Flow Characteristics: **Slow**  
Deposits: ☒ None ☐ Mud ☐ Sludge ☐ Debris ☐ Grease  
Silt Depth: **0.5** (in.) Deposits Extent: **Light**  
Infiltration: **None** Pipe Seal Cond: **Sound**
